MBTA GREEN LINE TESTS
RIVERSIDE LINE
DECEMBER 1972

VOLUME I
TEST DESCRIPTION

George W. Neat, Editor

SEPTEMBER 1973
FINAL REPORT

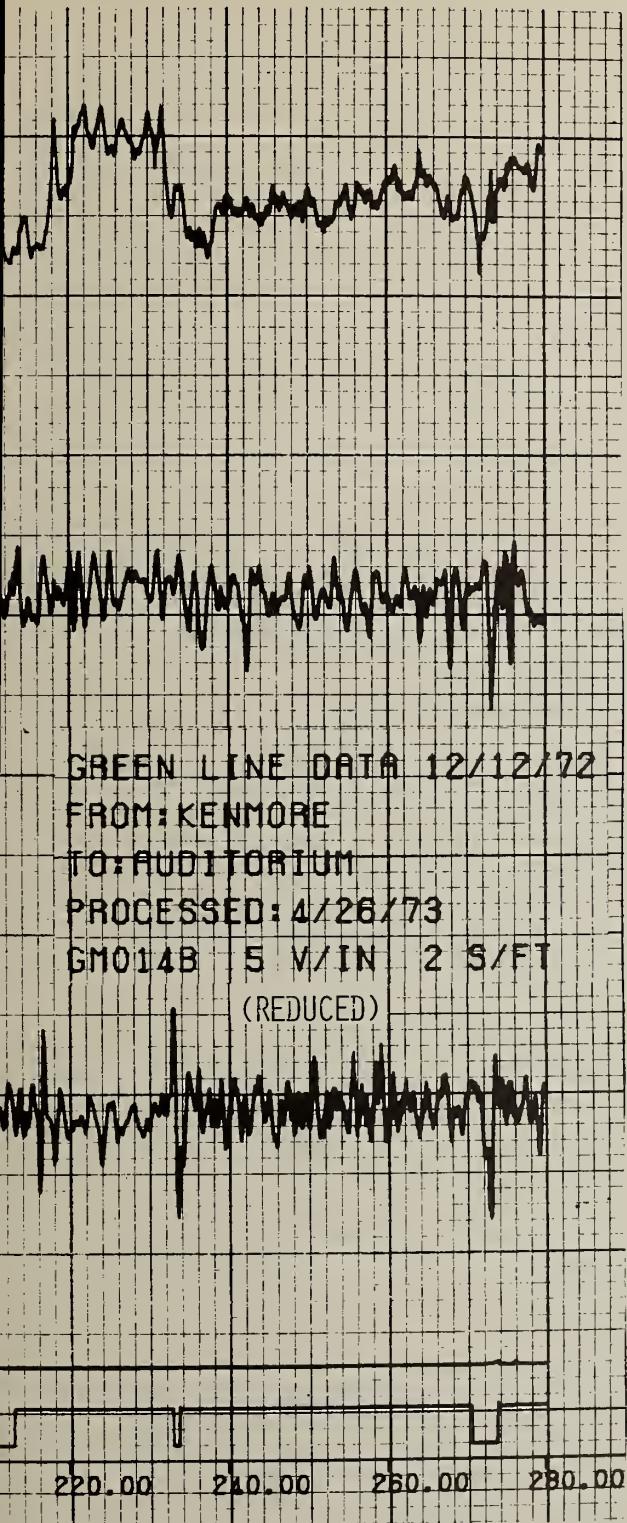
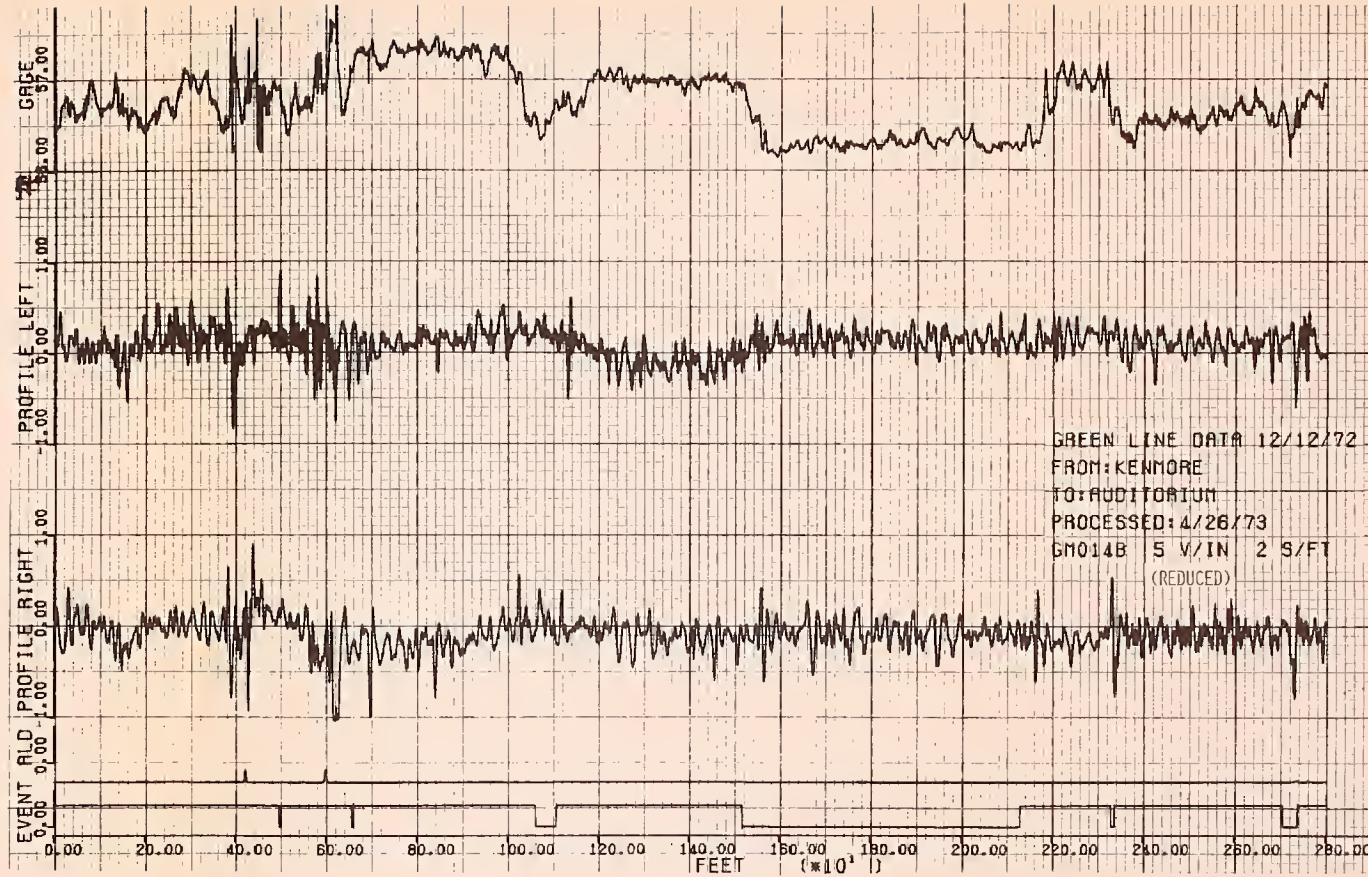
Figure C-1 Gage Data Plot

Page C of the figure provides a quick indication of the track classification relative to the IRT requirements for gage. Page B gives the location and magnitude of occurrences in Zones 1, 3, 4 and 6. Page A shows the location that the gage changes from one zone to another.

literal interpretation of the data. The section of track from Waban Station to Eliot Station is Class III. Twenty-two sections are Class II. The remaining 23 sections are below standard because of one or more places where the gage exceeds 57 3/4 inches or is less than 56 inches. However, of these sections, eleven have only one recorded defect. Many of the recorded defects occur in a region where extraneous metal such as guard rails may be effecting the recorded signal. A visual check of the track at these points is required to provide the final conclusion. The percentage of trackage that satisfies gage requirements provides a better measure of track quality. The percentage of the track in each section that meets the gage requirements for IRT Classes 2, 3 and 4 is also shown in Table C-1.

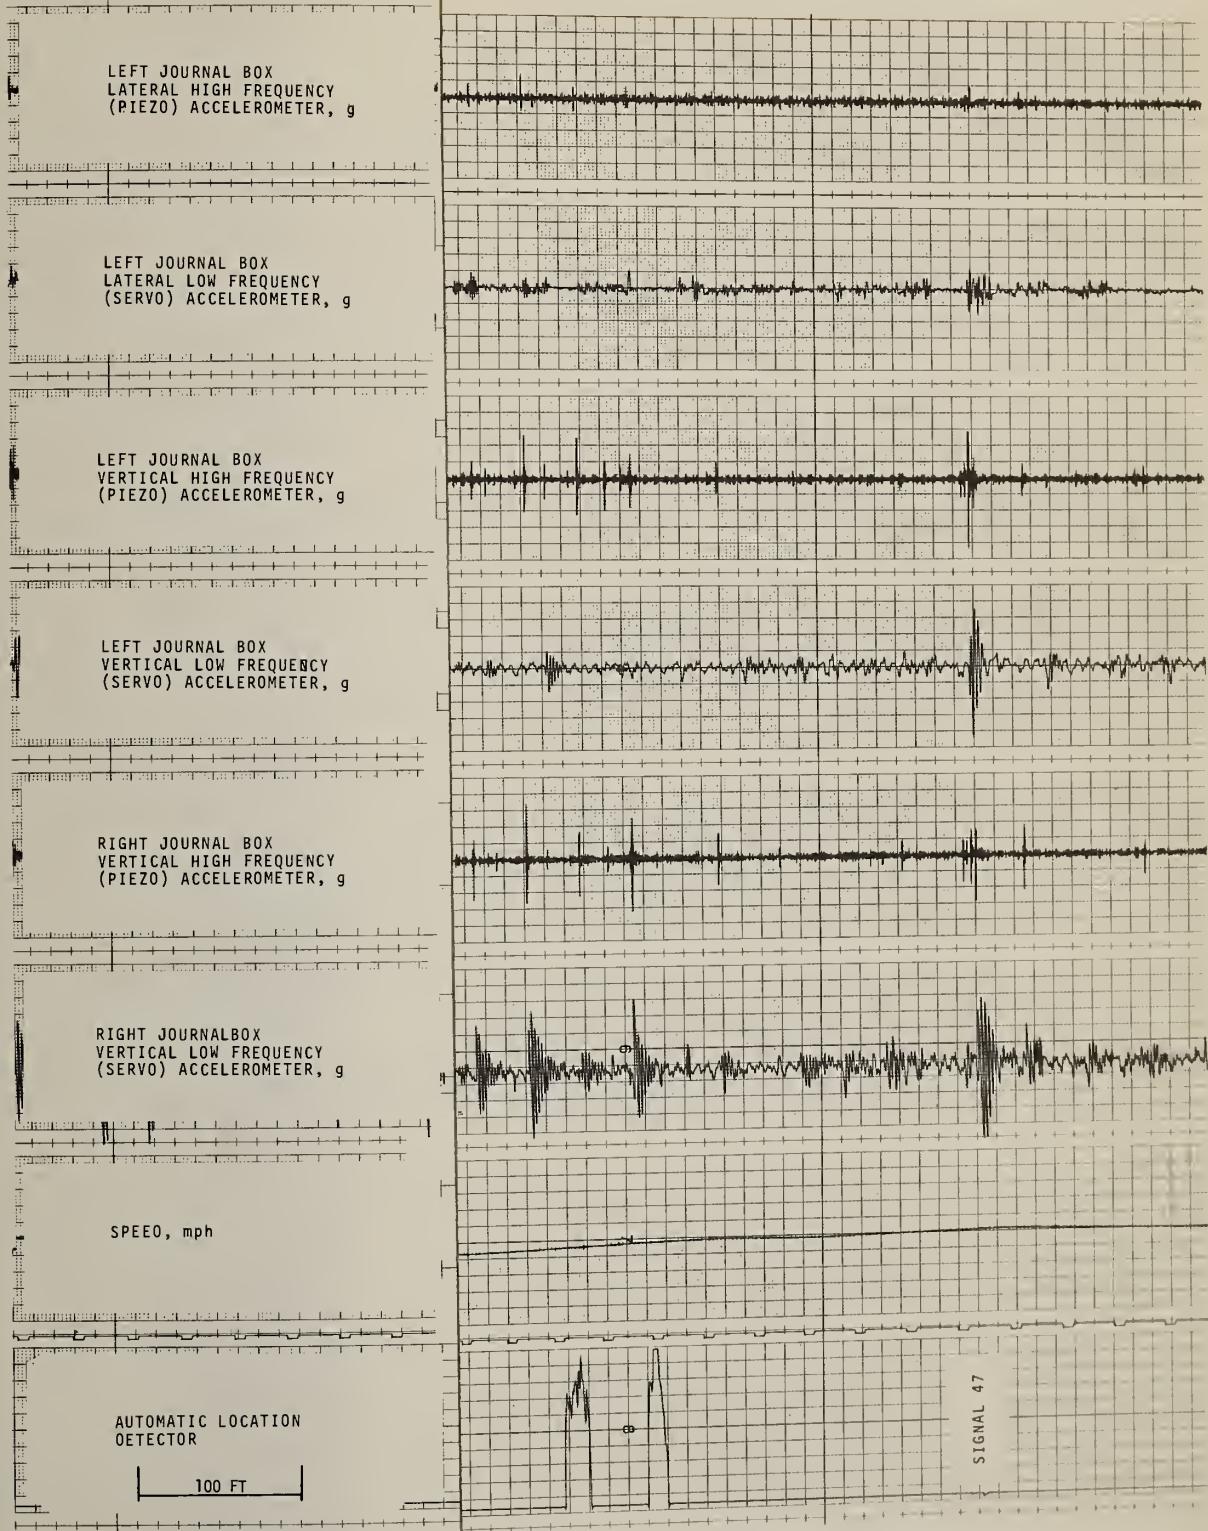
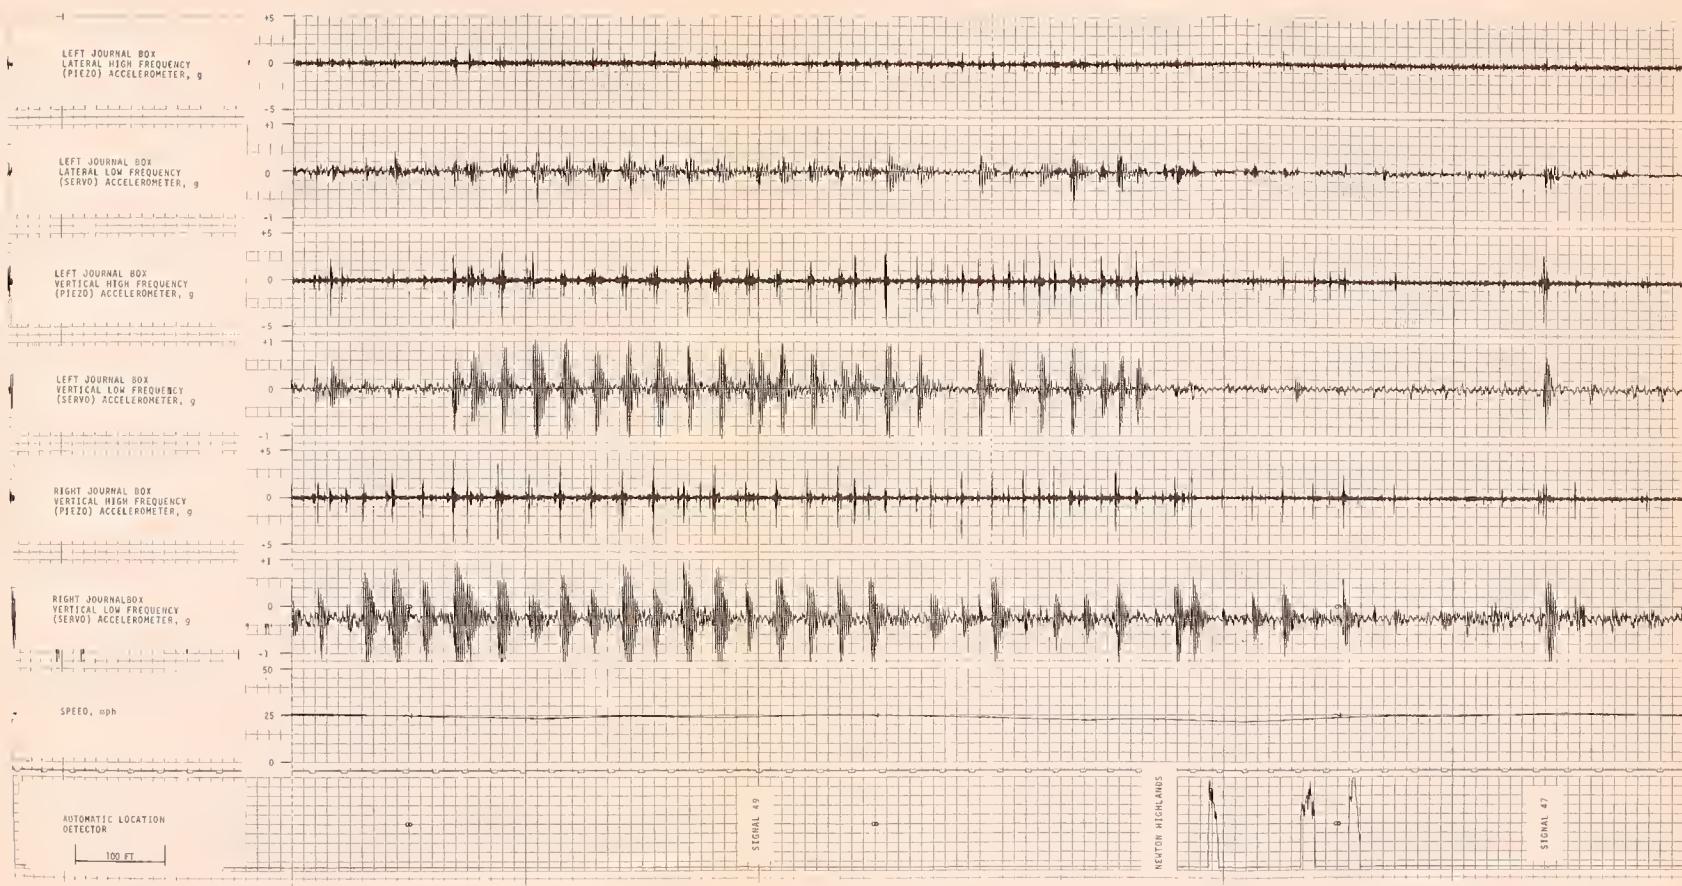
Figure D-3 Accelerometer Data

For the run from which the data of Figure D-3 was taken, the low frequency accelerometers were mounted using Lord 100PDL-1, low frequency (16 Hz), low damping ($T_{max} = 10$), vibration isolators. What seems to predominate in the low frequency vertical accelerometer output is the transient response of the vibration isolated mount to a train of acceleration pulses. These pulses are observed to occur at spacing intervals of approximately 33 feet, and are presumed to be soft (or low) spots in the ballast at the points where the rail joints were previously welded. Since the transient response of the isolation mount obliterates much of the track accelerometer data, it is concluded that use of a low damped, low frequency vibration isolation is not appropriate for this application. The -0.25 g bias shown in the right journal box vertical low frequency accelerometer data is caused by a deteriorating oscillograph pen motor drive assembly.

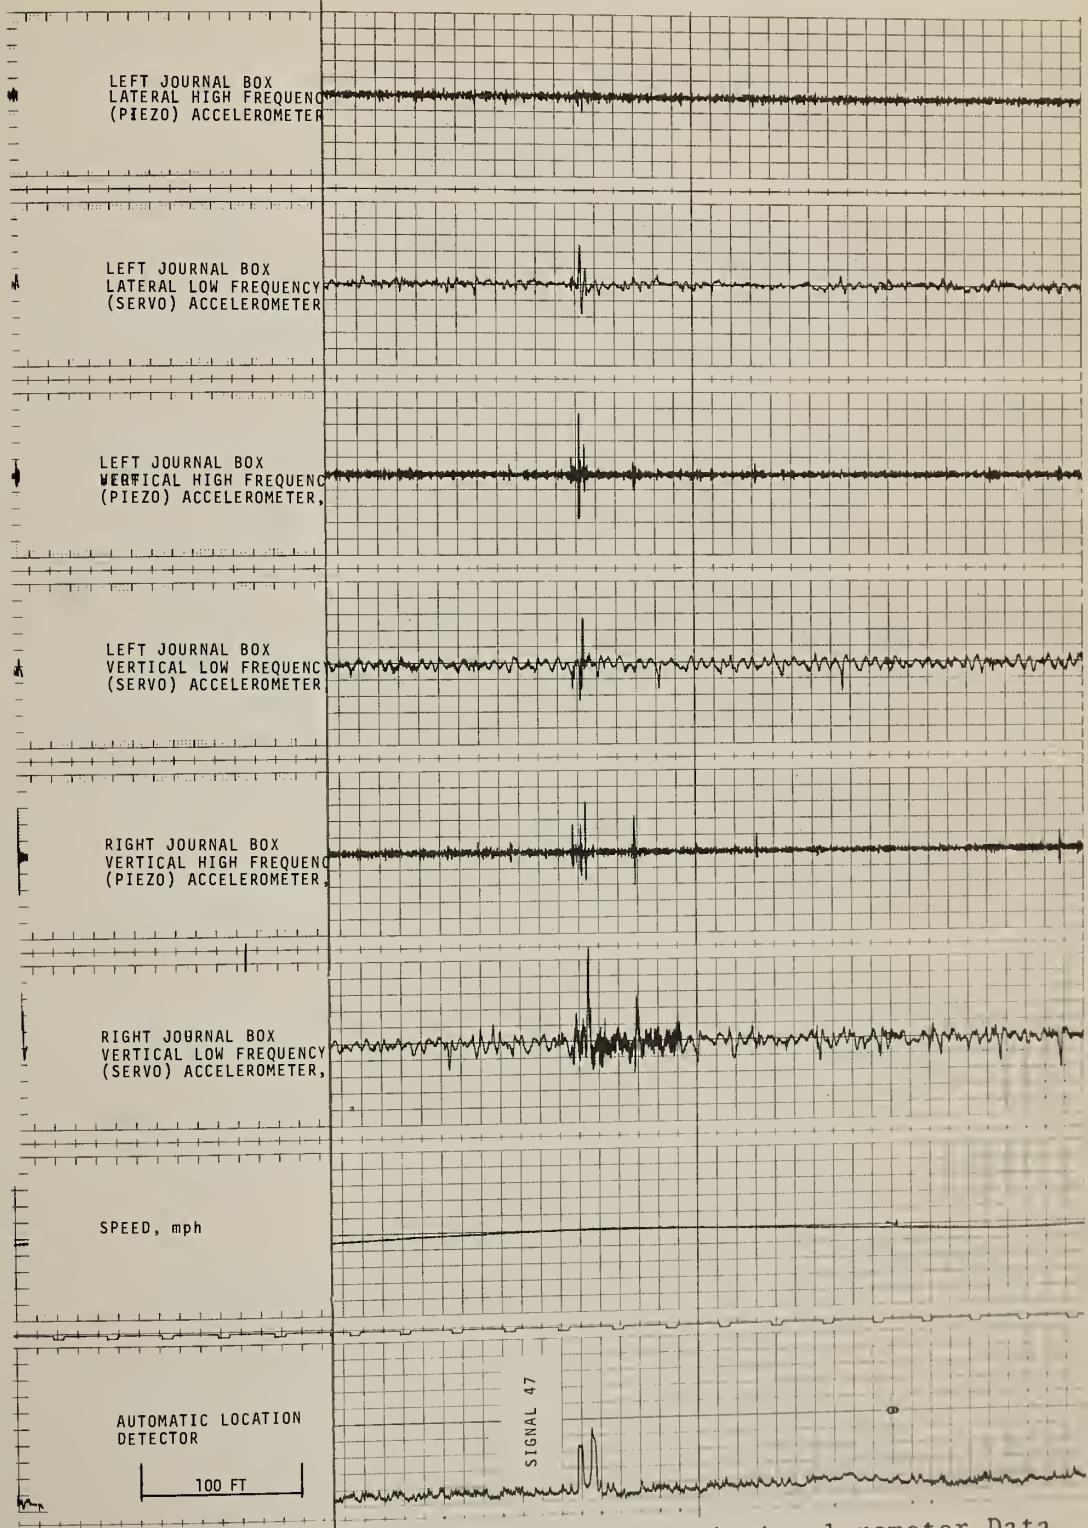
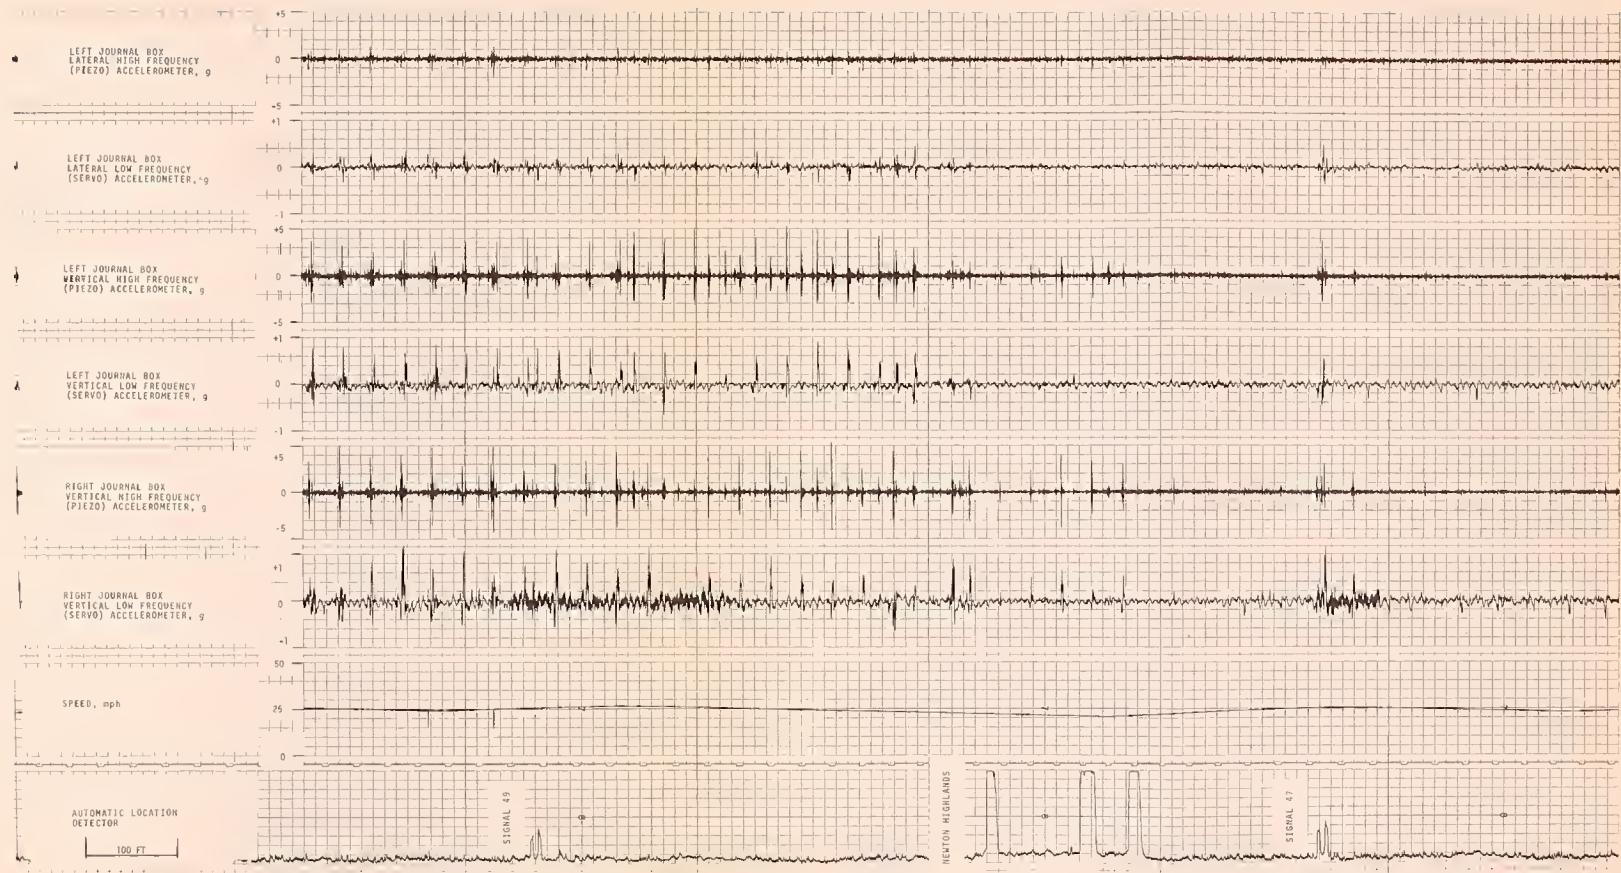
Figure D-4 Accelerometer Data

Figure D-4 shows journal box acceleration data from a run over the same section of track at approximately the same speed, 25 mph, but with Lord HTO-1 vibration isolators used in the low frequency accelerometer mounts. The HTO-1 isolators provide a resonance frequency of 40 to 85 Hz, depending on amplitude, and a

transmissability at resonance of T_{max} from 2.8 to 8, depending on amplitude. Figure D-4 shows that the transient response of the vibration isolated mount to a pulse of acceleration damps out within one cycle. Comparison of the peaks in the piezo and servo accelerometer data for the same axis of the same journal box shows the additional attenuation achieved by the added filtering used for the low frequency accelerometers. In fact, the piezo accelerometer data is significantly attenuated by the frequency response of the oscillographic chart recorders and the 80 Hz low pass filter. Monitoring the right journal box vertical piezo accelerometer data for the same section of track and the same run depicted here indicates that the larger pulses shown here actually approach 20 g in magnitude.

Between pulses, a ripple of periodic nature is indicated. It has an amplitude of 0.1 g and a typical wave length of about six to eight feet. At 25 mph, this translates into a frequency of about four to five Hz.

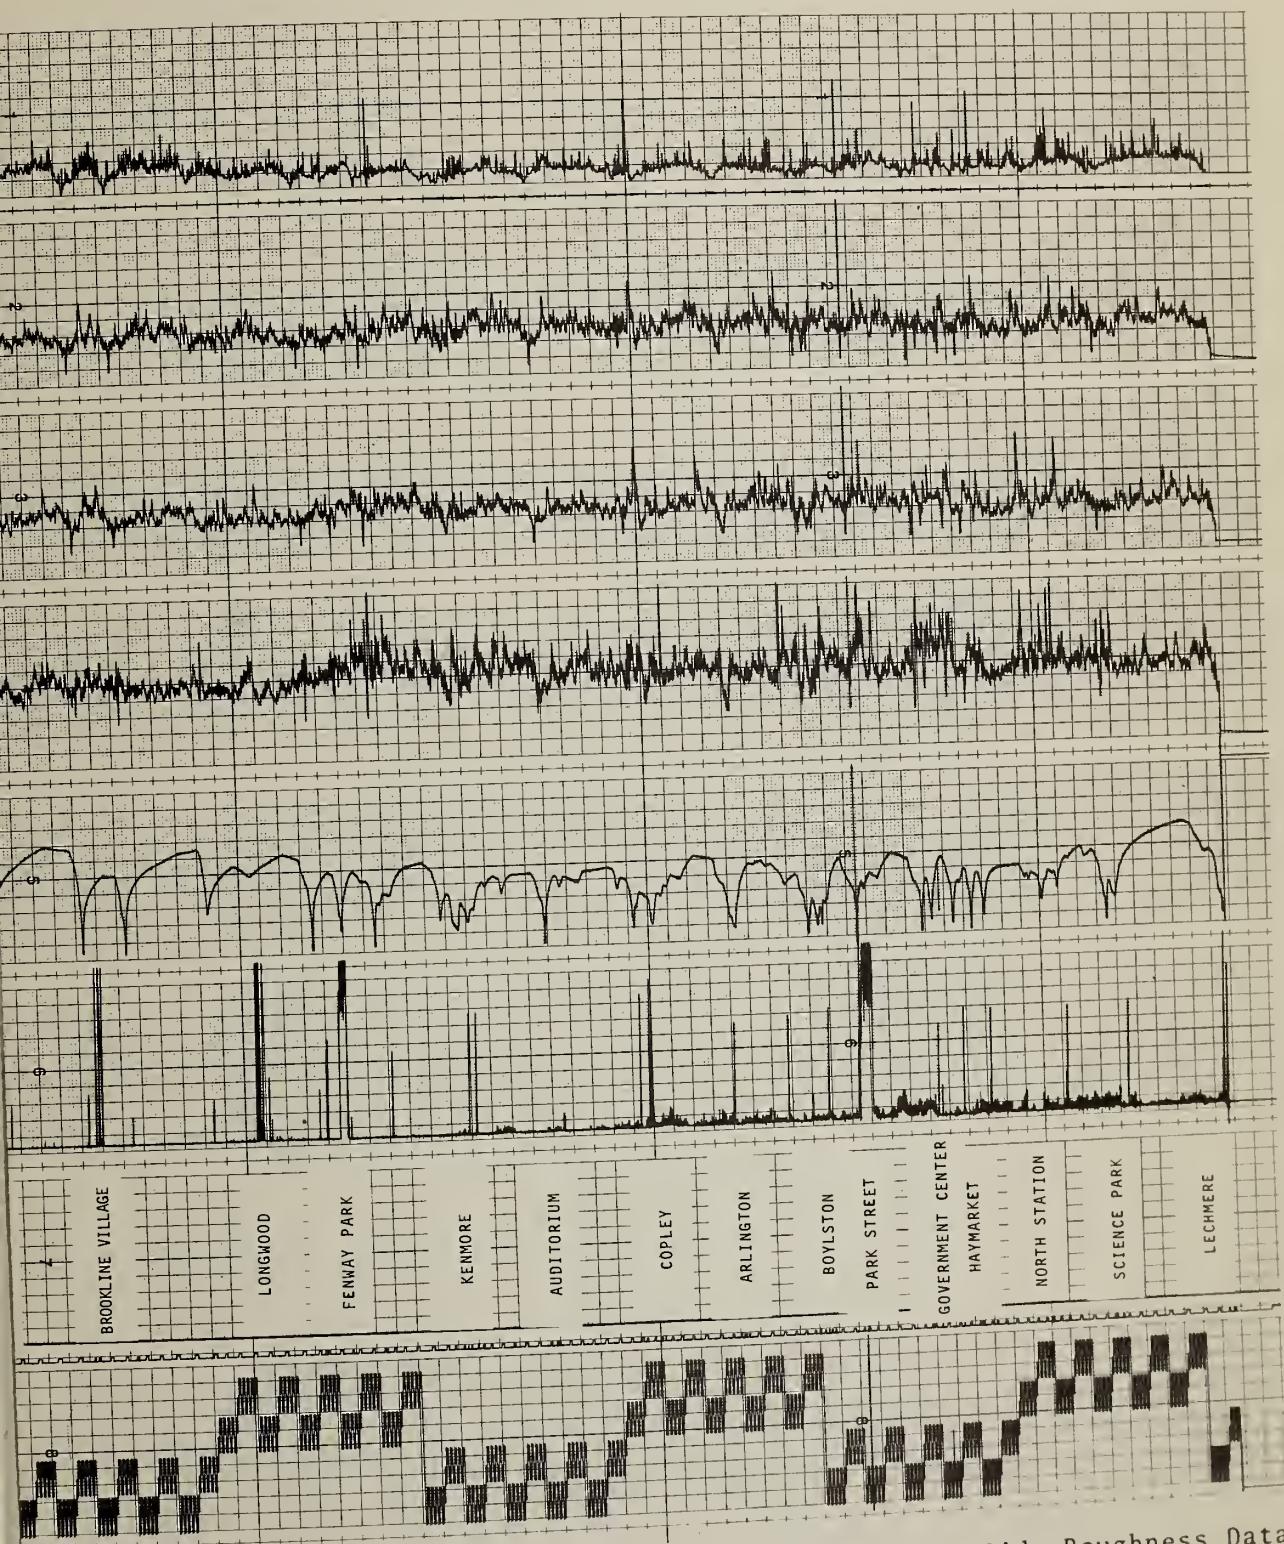
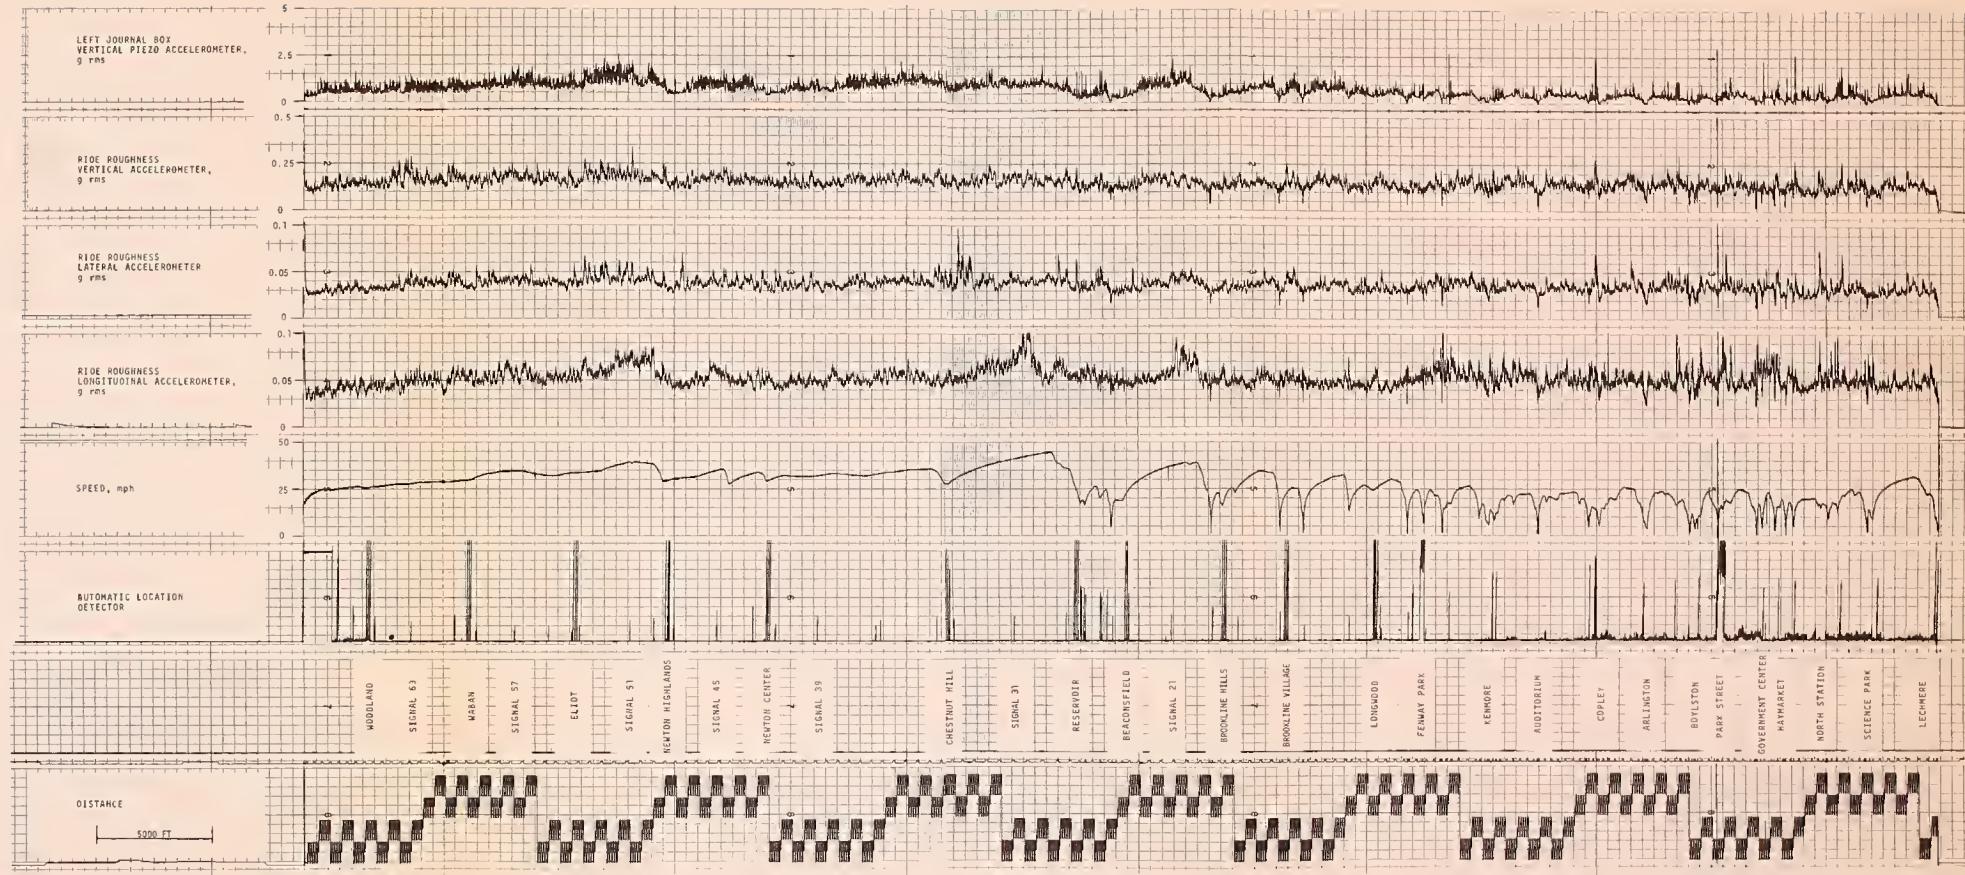
Figure E-1 Ride Roughness Data

Note that when the train stops, the journal box acceleration signal goes to zero, as expected, but the ride roughness vibration does not. This residual 0.03 to 0.04 g rms residual vibration level is presumed to be caused by machinery on board the car and/or by test crew or passengers walking around while the car is stopped. On board machinery would include the gasoline powered generator that was operated only while the test car was above ground (out of the tunnel).

In Figure E-1 there is one place, near Park Street station, where the traces make a large pulse. This is caused by the tape recorder being turned off. In Figure E-2, the tape recorder went off five times. Two of these times the tape recorder was turned off when the train stopped. The other three times, the tape recorder stopped itself while the train was moving and data was lost.
